Manhole Inspection Summary

Manhole # S15AA2004MH

Location Address: **2106 SOUTH RD** Cross Street: **CARTERDALE RD**

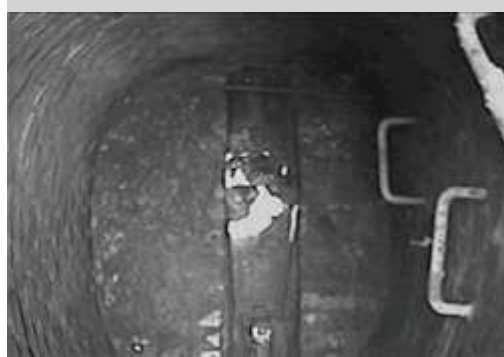
Top View

Bench ☒ Exists Material: **Brick** ☐ Parged ☒ **Debris** (not Condition related)
Condition: ☒ Sound ☐ Cracked ☐ Root Intrusion ☐ Deteriorated ☐ Leaks ☐ Debris

Channel Material: **Brick** ☐ Parged ☐ Debris (not Condition related)
Channel Exposure: **Fully Open** Junc Dist: **0** nearest .5 ft. Azimuth:
Condition: ☐ Sound ☐ Cracked ☐ Root Intrusion ☐ Deteriorated ☐ Leaks ☒ **Debris**

Bench and Channel debris.

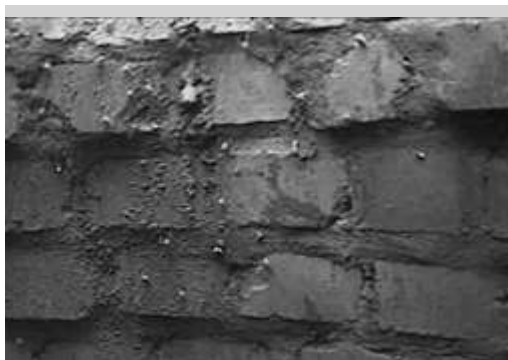
Defect

Corbel Material: **Brick and Stone** ☐ Parged Type: **Concentric/Eccentric**
Condition: ☒ Sound ☐ Cracked ☐ Root Intrusion ☐ Loose Brick ☐ Deteriorated
Infiltration: ☐ None ☐ Joint ☐ Cracks ☒ **Mortar** ☐ Roots ☒ **Wall**

Corbel infiltration.

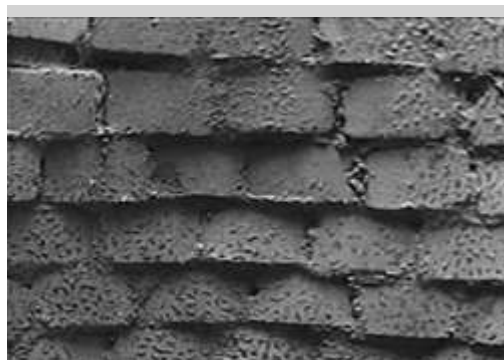
Defect

Barrel Material: **Brick** ☐ Parged
Shape: **Circular** Diameter: **48** (in.) Length: (in.)
Condition: ☒ Sound ☐ Cracked ☐ Root Intrusion ☐ Loose Brick ☐ Deteriorated
Infiltration: ☐ None ☐ Joint ☐ Cracks ☒ **Mortar** ☐ Roots ☒ **Wall**

Barrel infiltration.

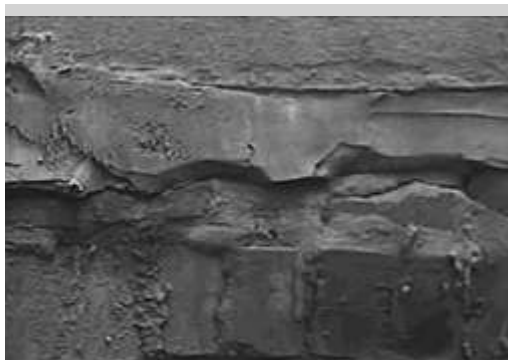
Defect

Frame Offset: **0** (in.) Condition: ☐ Sound ☐ Cracked ☒ **Leaks**

Chimney / Frame Adjustment ☒ Exists Material: **Brick** ☒ Parged Height: **12** (in.)
Condition: ☒ Sound ☐ Cracked ☐ Root Intrusion ☐ Loose Brick ☐ Deteriorated
Infiltration: ☐ None ☒ **Joint** ☐ Cracks ☐ Mortar ☐ Roots ☐ Wall

Frame leaks. Adjustment infiltration.

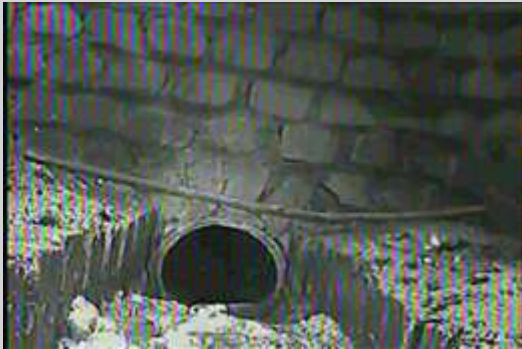
8 in. Circular Gravity Sewer Pipe Out @ 12 O'Clock

Deposits: ☐ None ☒ **Mud** ☐ Sludge ☒ **Debris** ☐ Grease

Silt Depth: **1** (in.) Deposits Extent: **Light**

Infiltration: **Evidence** Pipe Seal Cond: **Unknown**

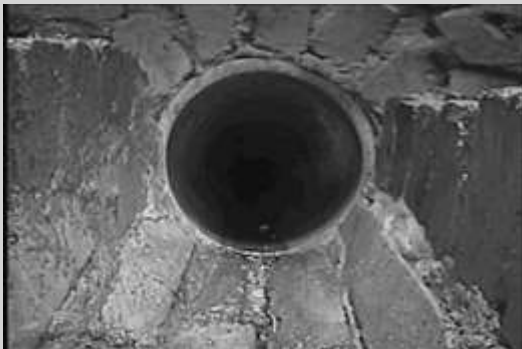
8 in. Circular Gravity Sewer Pipe In @ 6 O'Clock

Infiltration: **Evidence** Pipe Seal Cond: **Unknown**
